**Flood Control Project Maintenance
Levee Inspections**

Fall 2015 Levee Maintenance Deficiency Summary Report

Sutter Maintenance Yard Maintenance Area 0013

Waterway			Bank	Unit Miles
Unit No. 01 Cherokee Canal			Right	18.19
	Spring (March - May)	Summer (June - August)	(September - November) Fall	Winter (December - February)
Unit Maintenance Rating (Fall Only)			A	
Date of Inspection	05/06/2015 - 05/06/2015		11/06/2015 - 11/06/2015	
DWR Inspector	Bob Duffey		Bob Duffey	
Accompanied By	Shawn Freitag Sutter Maintenance Yard		Shawn Freitag Sutter Maintenance Yard

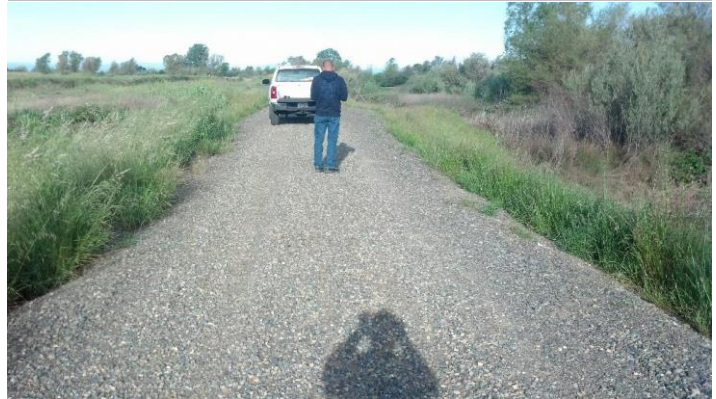
Photo 1 of 3 : UCIP_FA_2015_5286.jpg

LM Start	5.80	Rating **	U	Issue No.	924
LM End	5.80	Issue Type +	En	Location *	WS
Category	Supplemental			GPS Latitude/Longitude	
				Start	End
Item	DWR UCIP Field Study			39.523381 °	39.523381 °
				-121.701270 °	-121.701270 °
DWR ID					
Action/Comments					
Inspector Comments: FS_ID:46219					
DS_ID:16411					
EP_NO: N/A					
FS_HLM: 5.853					
Repair Type: Urgent					
Crossing Status: Found

Overview looking south

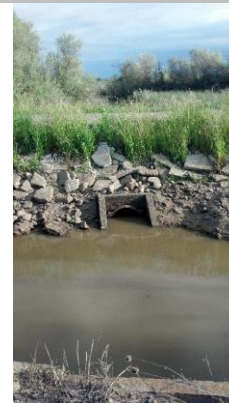
Photo 2 of 3 : UCIP_FA_2015_5287.jpg

Headwall and damaged/missing screw gate on land side of levee

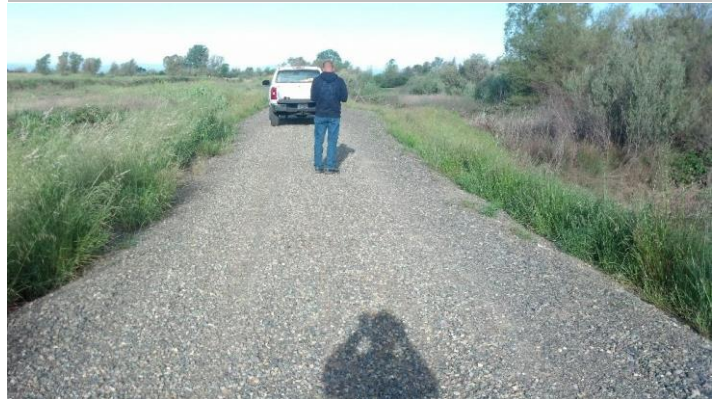
Photo 1 of 3 : UCIP_FA_2015_5289.jpg

LM Start	5.80	Rating **	M	Issue No.	925
LM End	5.80	Issue Type +	En	Location *	WS
Category	Supplemental			GPS Latitude/Longitude	
				Start	End
Item	DWR UCIP Field Study			39.523370 °	39.523370 °
				-121.701330 °	-121.701330 °
DWR ID					
Action/Comments					
Inspector Comments: FS_ID:46220 DS_ID:16466 EP_NO: 13170 FS_HLM: 5.856 Repair Type: Non-Urgent Crossing Status: Found UCIP Comments: 6/30/2015 High water on both side of crossing still. Slopes appear in good condition. Both pipe ends and gates were submerged.Limited inspection on WS and LS slopes due to dense vegetation. Need photos of cleared WS & LS slopes. This crossing was listed in the USACE Periodic Inspection report as Corp's inspect ID# USACE_CESPK_M13H_2011_p_0058 for high water unable to see crossing.7/9/2013 Same as last inspection.12/9/2013 Same as last inspection.5/29/2014 Same as last inspection. FIELD_STRUCT_DESC: 36 inch corrugated metal pipe through the levee approximately 7 feet below crown. Flap gate is located on the waterward side. (13170-1981) FS Date: 07/16/2015

Overview photo of crossing looking downstream.

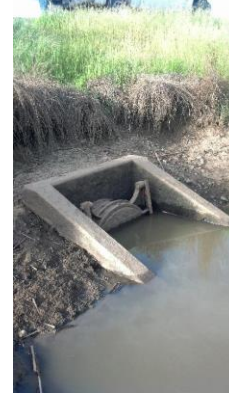
Photo 2 of 3 : UCIP_FA_2015_5290.jpg

Flap gate on WS unable to determine slope condition on WS due to overgrown vegetation.

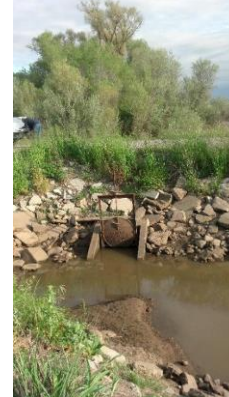
Photo 3 of 3 : UCIP_FA_2015_5291.jpg

Headwall and screw gate on land side of levee

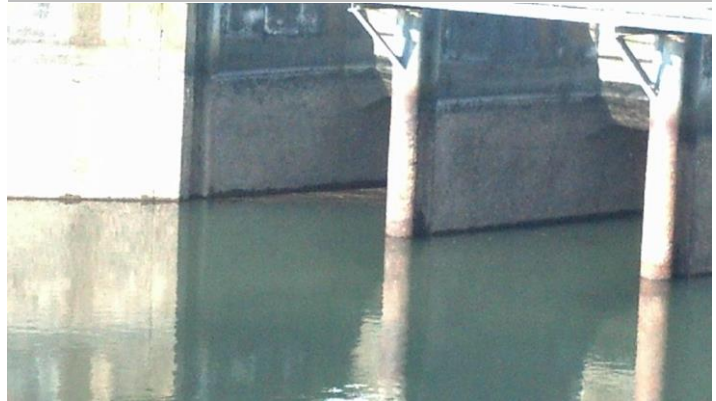
Photo 1 of 3 : UCIP_FA_2015_4715.jpg

LM Start	6.07	Rating **	M	Issue No.	926
LM End	6.07	Issue Type +	En	Location *	WS
Category	Supplemental			GPS Latitude/Longitude	
				Start	End
Item	DWR UCIP Field Study			39.522457 °	39.522457 °
				-121.706030 °	-121.706030 °
DWR ID					
Action/Comments					
Inspector Comments: FS_ID:46223					
DS_ID:17374					
EP_NO: N/A					
FS_HLM: 6.125					
Repair Type: Non-Urgent					
Crossing Status: Found

3 of 3 Eight (8) foot by Ten (10) foot siphon. (downstream conduit)

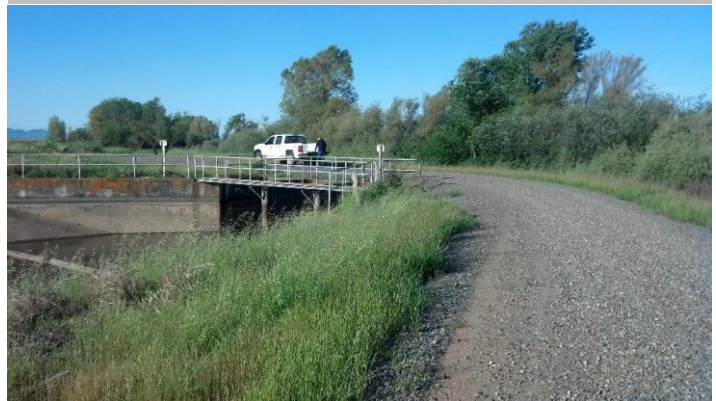
Photo 2 of 3 : UCIP_FA_2015_4716.jpg

Overview looking south from levee

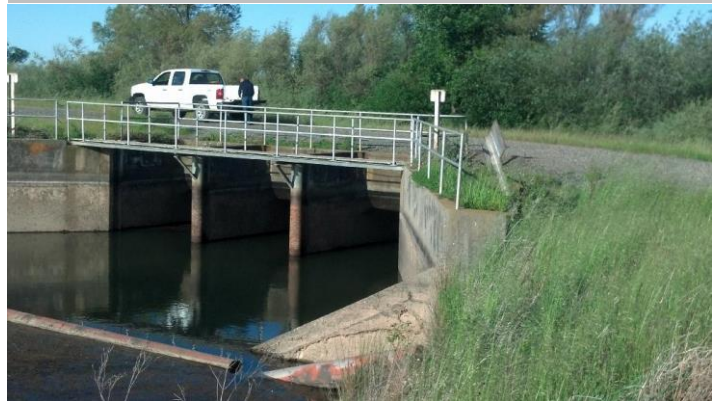
Photo 3 of 3 : UCIP_FA_2015_4717.jpg

LM Start	6.07	Rating **	M	Issue No.	926 (cont)
LM End	6.07	Issue Type +	En	Location *	WS
Category	Supplemental			GPS Latitude/Longitude	
				Start	End
Item	DWR UCIP Field Study			39.522457 °	39.522457 °
				-121.706030 °	-121.706030 °
DWR ID					
Action/Comments					
Inspector Comments: FS_ID:46223					
DS_ID:17374					
EP_NO: N/A					
FS_HLM: 6.125					
Repair Type: Non-Urgent					
Crossing Status: Found

View of Western Canal Siphon (Richvale Siphon) looking south.

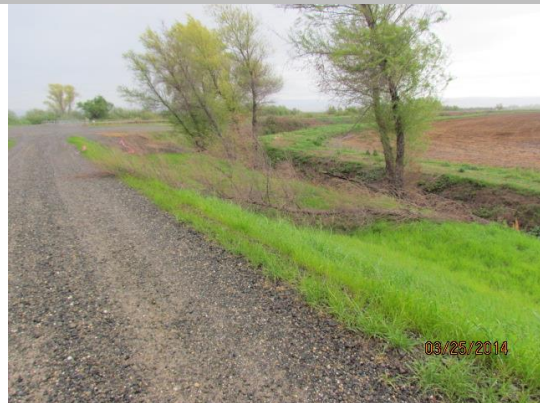
Photo 1 of 1 : FA_2015_MA0013_301_55_20150910_00014.jpg

LM Start	6.12	Rating **	M	Issue No.	55
LM End	6.12	Issue Type +	Ma	Location *	LS
Category	Earthen Levee			GPS Latitude/Longitude	
				Start	End
Item	Encroachments			39.521634 °	39.521634
				-121.706184 °	-121.706184
DWR ID	DWR_MA0013_02_s_2014_55				
Action/Comments					
Tree or limb					
Inspector Comments: Remove the tree limbs from the landside slope.

View of the tree limbs on the landside slope and toe.

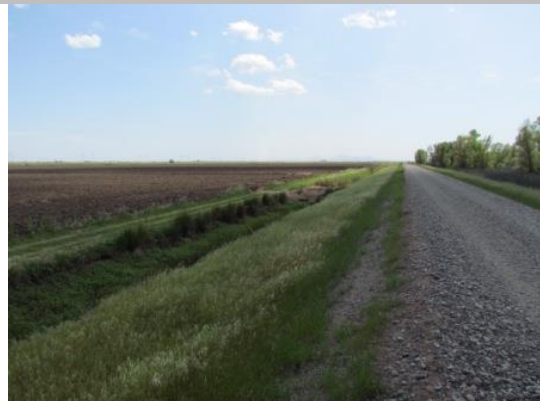
Photo 1 of 1 : FA_2015_MA0013_301_12_20150910_00005.jpg

LM Start	6.18	Rating **	M	Issue No.	12
LM End	7.54	Issue Type +	En	Location *	LS
Category	Earthen Levee			GPS Latitude/Longitude	
				Start	End
Item	Encroachments			39.520843 °	39.502958 °
				-121.706345 °	-121.716953 °
DWR ID	DWR_MA0013_02_s_2012_12				
Action/Comments					
Ditch

View of the agricultural ditch along the toe.

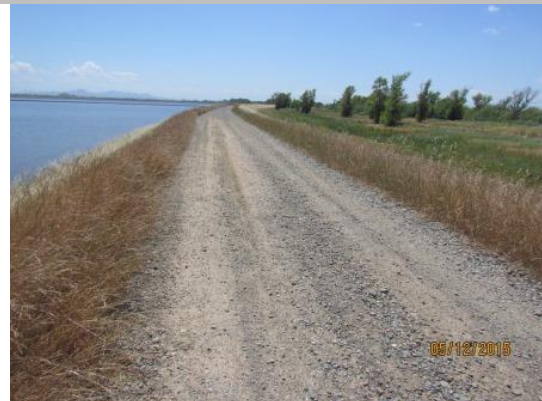
Photo 1 of 1 : FA_2015_MA0013_301_60_20150910_00017.jpg

View of the ruts in the crown roadway.

Action/Comments					
Add appropriate material and re-grade the levee to bring the crown above the design elevation. Inspector Comments: Repair the ruts in the crown roadway.

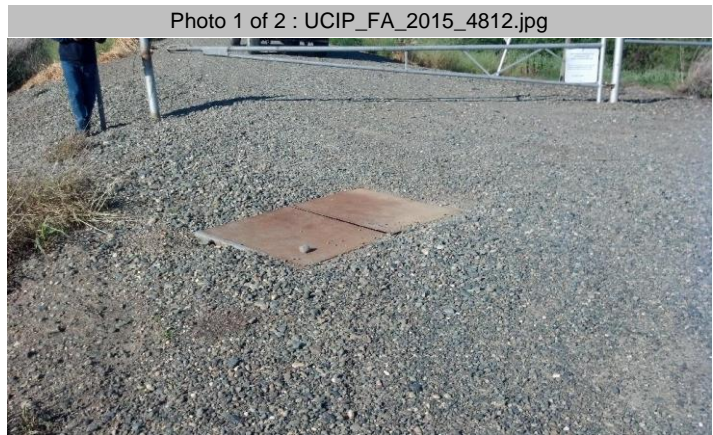
Action/Comments					
Inspector Comments: FS_ID:46228 DS_ID:16413 EP_NO: 14704 FS_HLM: 8.384 Repair Type: Non-Urgent Crossing Status: Indicator Found UCIP Comments: 6/30/2015 Crossing is in good condition. Unusre on the permit issues below.11/4/14 (DWR-Olivia Magana) Need to contact owner to determine whether both communication are still active and same alignment? permit 14704 (LM 8.38) and 10589 (see LM 8.39) Priority changed in Part IX from No Action Needed to Non-Urgent.5/29/2014 Same as last inspection.12/4/2013 Same as last inspection.7/9/2013 Same as last inspection.Unable to verify whether this crossing includes both communication cable lines under permit 14704 (LM 8.38) and 10589 (see LM 8.39). FIELD_STRUCT_DESC: Fiber optic cable through levee at approximately 3.5 feet. The cable section across the channel is attached to the Cherokee Canal Dridge. (Permit No. 14704-1987) FS Date: 07/16/2015

Buried cable box located on the LS edge.

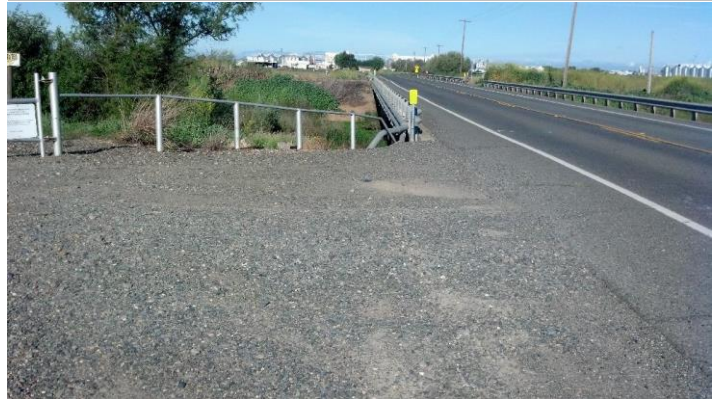
Photo 2 of 2 : UCIP_FA_2015_4813.jpg

LM Start	8.30	Rating **	M	Issue No.	928 (cont)
LM End	8.30	Issue Type +	En	Location *	CR
Category	Supplemental			GPS Latitude/Longitude	
				Start	End
Item	DWR UCIP Field Study			39.493850 °	39.493850 °
				-121.724780 °	-121.724780 °
DWR ID					
Action/Comments					
Inspector Comments: FS_ID:46228 DS_ID:16413 EP_NO: 14704 FS_HLM: 8.384 Repair Type: Non-Urgent Crossing Status: Indicator Found UCIP Comments: 6/30/2015 Crossing is in good condition. Unusre on the permit issues below.11/4/14 (DWR-Olivia Magana) Need to contact owner to determine whether both communication are still active and same alignment? permit 14704 (LM 8.38) and 10589 (see LM 8.39) Priority changed in Part IX from No Action Needed to Non-Urgent.5/29/2014 Same as last inspection.12/4/2013 Same as last inspection.7/9/2013 Same as last inspection.Unable to verify whether this crossing includes both communication cable lines under permit 14704 (LM 8.38) and 10589 (see LM 8.39). FIELD_STRUCT_DESC: Fiber optic cable through levee at approximately 3.5 feet. The cable section across the channel is attached to the Cherokee Canal Dridge. (Permit No. 14704-1987) FS Date: 07/16/2015

WS view cable line attached to highway bridge.

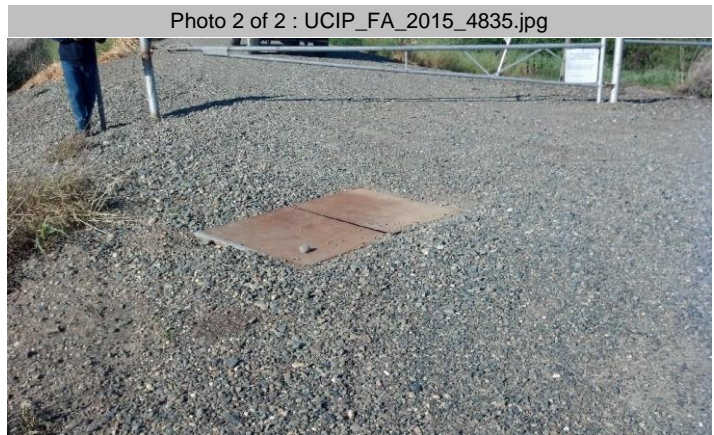
Action/Comments					
Inspector Comments: FS_ID:46229					
DS_ID:16404					
EP_NO: 10589A					
FS_HLM: 8.39					
Repair Type: Non-Urgent					
Crossing Status: Indicator Found					
UCIP Comments: 6/30/2015 Crossing appears in good condition.					
Unsure on the permit issues listed below.11/4/14 (DWR-Olivia					
Magana) Need to contact owner to determine whether both					
communication are still active and same alignment? permit 14704 (LM

8.38) and 10589 (see LM 8.39) Priority changed in Part IX from No					
Action Needed to Non-Urgent.5/29/2014 Same as last					
inspection.12/4/2013 Same as last inspection.7/9/2013 Same as					
last inspection.Unable to verify whether this crossing includes both					
communication cable lines under permit 14704 (LM 8.38) and 10589					
(see LM 8.39).					
FIELD_STRUCT_DESC: 4 inch steel pipe, contains three telephone					
cables, through the levee at approximately 4 feet below the crown. The					
cable through the channel is buried approximately 5 feet deep. (Permit					
No. 10589-1987)					
FS Date: 07/16/2015

Buried cable box located on the landside edge.

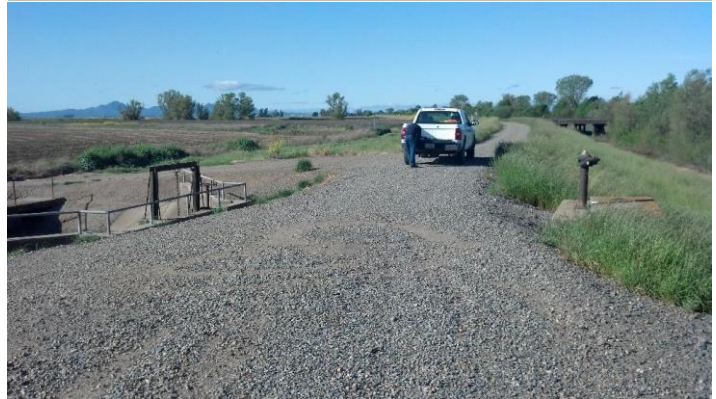
Photo 1 of 3 : UCIP_FA_2015_5119.jpg

Action/Comments					
Inspector Comments: FS_ID:46233					
DS_ID:16838					
EP_NO: N/A					
FS_HLM: 9.664					
Repair Type: Non-Urgent					
Crossing Status: Found					
UCIP Comments: 6/30/2015 Path to access the WS flap gate was getting overgrown with vegetation but other than that everything with the crossing looked in good condition. This crossing was listed in the USACE Periodic Inspection report as Corp's inspect ID# USACE_CESPK_M13F_2011_p_0080 for limited visibility of LS slide gate and WS flap gate. 7/9/2013 Same as last inspection. 12/4/2013 Same as last inspection. 5/28/2014 Same as last inspection.					
FIELD_STRUCT_DESC: Crossing is part of the Richvale Irrigation District siphon structure. 36 inch CM pipe that drains into Cherokee Canal at about 11.2 feet below the crown. (USACE-1962) Slide gate is located on landward side. Flap gate is located on waterward side. Crossing angles to the southwest to a flap gate & headwall located about 60 feet from waterward toe. This entry matches the Drainage or Irrigation Structure referenced in O&M manual (HLM 9.66).

Overview of levee crown at crossing looking D/S.

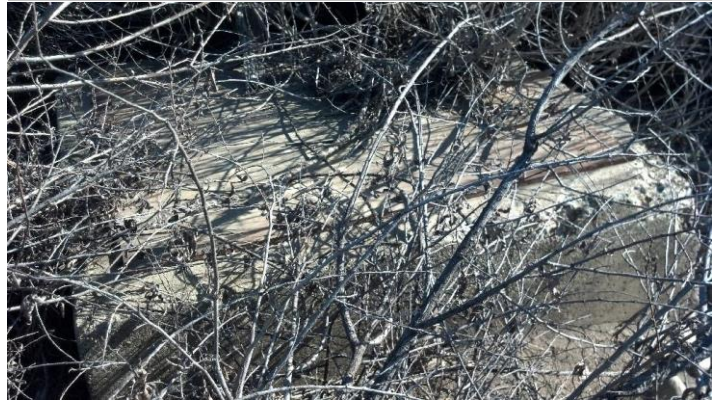
Photo 2 of 3 : UCIP_FA_2015_5120.jpg

WS view-access well located 60 feet from WS toe.

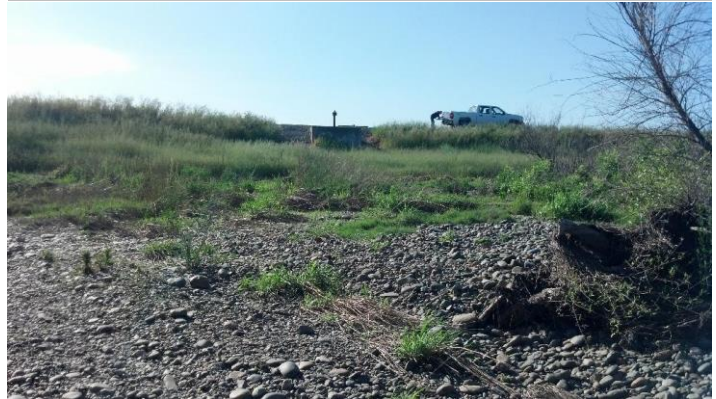
Photo 3 of 3 : UCIP_FA_2015_5121.jpg

View of crossing looking from channel towards WS levee.

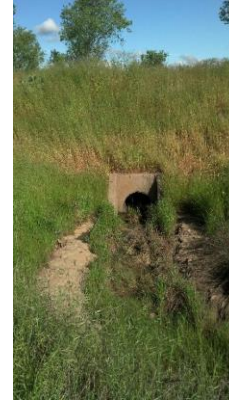
Photo 1 of 3 : UCIP_FA_2015_5122.jpg

LM Start	9.57	Rating **	M	Issue No.	931
LM End	9.57	Issue Type +	En	Location *	CR
Category	Supplemental			GPS Latitude/Longitude	
				Start	End
Item	DWR UCIP Field Study			39.477335 °	39.477335 °
				-121.735340 °	-121.735340 °
DWR ID					
Action/Comments					
Inspector Comments: FS_ID:46234 DS_ID:16839 EP_NO: N/A FS_HLM: 9.675 Repair Type: Non-Urgent Crossing Status: Found UCIP Comments: 6/30/2015 WS flapgate is silted over and unable to open. Needs to be dug out.Limited inspection on WS and LS slopes due to dense vegetation. Need photos of WS and LS slopes during next inspection with cleared slopes.7/9/2013 Same as last inspection.12/4/2013 Slopes were cleared of vegetation and are in good condition.5/28/2014 Same as last inspection. FIELD_STRUCT_DESC: 30 inch corrugated metal pipe with flapgate on the waterward side located approximately 11.5 feet below crown. (USACE-1962) This entry matches the Drainage or Irrigation Structure referenced in O&M manual (HLM 9.68). FS Date: 07/16/2015

View of crossing from LS. Dense vegetation along LS slope limited visual inspection. (LS Photo 1 of 2)

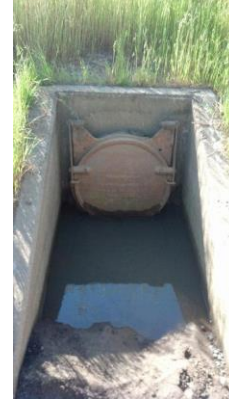
Photo 3 of 3 : UCIP_FA_2015_5124.jpg

WS view of crossing. Dense vegetation along WS slope limited visual inspection. (WS Photo 1 of 2)

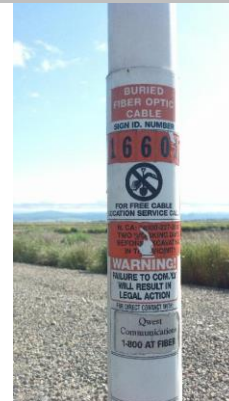
Photo 1 of 3 : UCIP_FA_2015_5125.jpg

LM Start	9.66	Rating **	M	Issue No.	932
LM End	9.66	Issue Type +	En	Location *	CR
Category	Supplemental			GPS Latitude/Longitude	
				Start	End
Item	DWR UCIP Field Study			39.476260 °	39.476260 °
				-121.736230 °	-121.736230 °
DWR ID					
Action/Comments					
Inspector Comments: FS_ID:46236 DS_ID:18912 EP_NO: N/A FS_HLM: 9.764 Repair Type: Non-Urgent Crossing Status: Indicator Found UCIP Comments: 6/30/2015 Crossing is in good condition.Unable to determine if crossing is an authorized or unauthorized encroachment. Unable to find permit number for this encroachment. Will need to coordinate with LMA Superintendent and DWR-Inspector, photo includes utility contact information.7/9/2013 Same as last inspection.12/4/2013 Same as last inspection.5/28/2014 Same as last inspection. FIELD_STRUCT_DESC: Buried fiber optic line through the levee at depth unknown. Owner of line is Qwest Communications 1-800 At Fiber Sign ID Number 16601. (Qwest Communication) FS Date: 07/16/2015

Marker for buried fiber optic cable on LS with contact information.

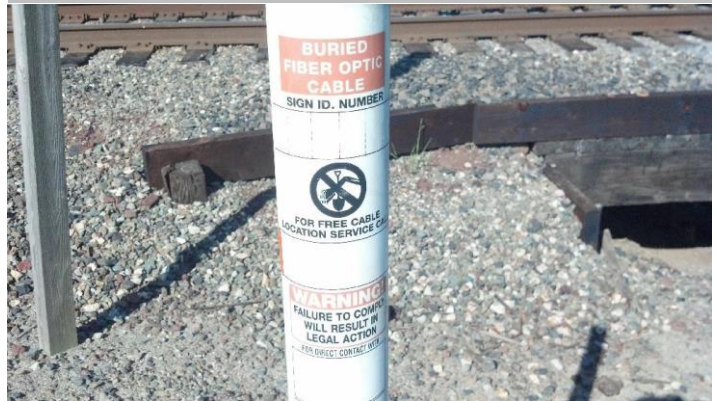
Photo 2 of 3 : UCIP_FA_2015_5126.jpg

Marker for buried fiber optic cable on WS.

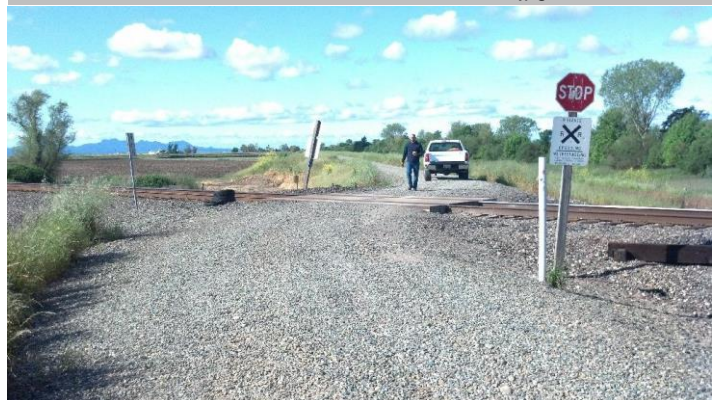
Photo 3 of 3 : UCIP_FA_2015_5127.jpg

Overview of levee crown at crossing.

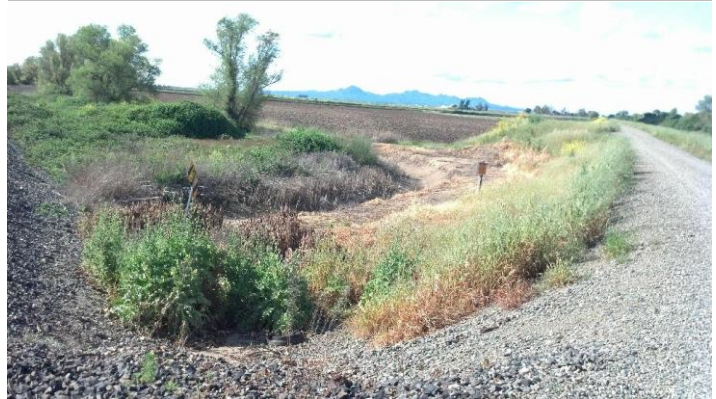
Photo 1 of 3 : UCIP_FA_2015_5128.jpg

LM Start	9.67	Rating **	U	Issue No.	933
LM End	9.67	Issue Type +	En	Location *	CR
Category	Supplemental			GPS Latitude/Longitude	
				Start	End
Item	DWR UCIP Field Study			39.476140 °	39.476140 °
				-121.736390 °	-121.736390 °
DWR ID					
Action/Comments					
Inspector Comments: FS_ID:46237					
DS_ID:18913					
EP_NO: N/A					
FS_HLM: 9.776					
Repair Type: Urgent					
Crossing Status: Indicator Found

View of LS slope and marker.

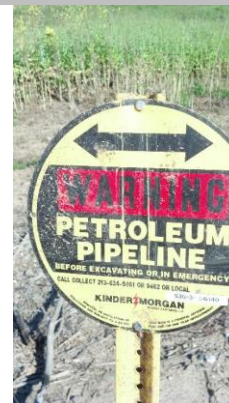
Photo 2 of 3 : UCIP_FA_2015_5129.jpg

WS marker with utility contact information.

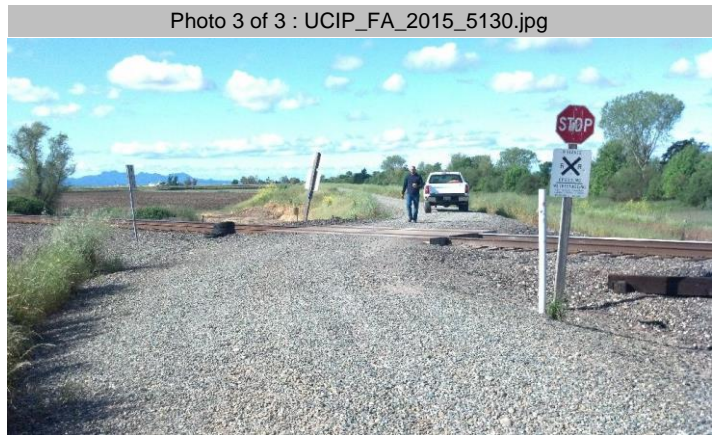
LM Start	9.67	Rating **	U	Issue No.	933 (cont)
LM End	9.67	Issue Type +	En	Location *	CR
Category	Supplemental			GPS Latitude/Longitude	
				Start	End
Item	DWR UCIP Field Study			39.476140 °	39.476140 °
				-121.736390 °	-121.736390 °
DWR ID					
Action/Comments					
Inspector Comments: FS_ID:46237					
DS_ID:18913					
EP_NO: N/A					
FS_HLM: 9.776					
Repair Type: Urgent					
Crossing Status: Indicator Found

Overview of levee crown at crossing.

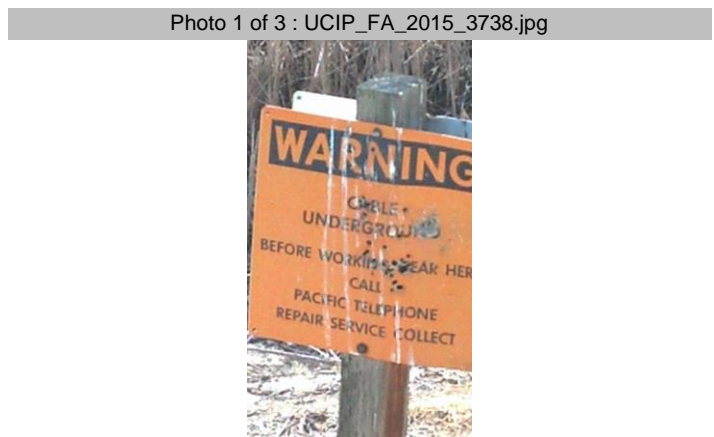
LM Start	9.68	Rating **	M	Issue No.	934
LM End	9.68	Issue Type +	En	Location *	CR
Category	Supplemental			GPS Latitude/Longitude	
				Start	End
Item	DWR UCIP Field Study			39.475960 °	39.475960 °
				-121.736540 °	-121.736540 °
DWR ID					
Action/Comments					
Inspector Comments: FS_ID:46238 DS_ID:18914 EP_NO: N/A FS_HLM: 9.791 Repair Type: Non-Urgent Crossing Status: Indicator Found UCIP Comments: 6/30/2015 Crossing appears to be in good condition. It is still unknown whether this crossing was authorized or unauthorized.Unable to determine if crossing is an authorized or unauthorized encroachment. Unable to find permit number for this crossing. Will need to coordinate with Pacific Telephone to determine if permit exist for this crossing.7/9/2013 Same as last inspection.12/4/2013 Same as last inspection.5/28/2014 Same as last inspection. FIELD_STRUCT_DESC: Underground cable through the levee at depth unknown. Owner of encroachment is Pacific Telephone. FS Date: 07/16/2015

Underground cable marker with contact information.

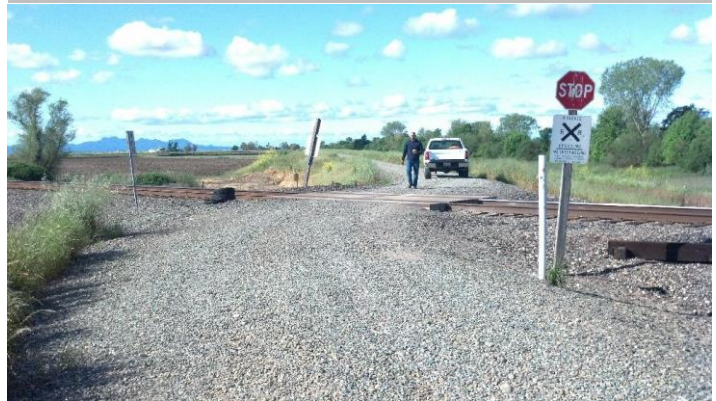
Photo 2 of 3 : UCIP_FA_2015_3739.jpg

Overview of levee crown at crossing.

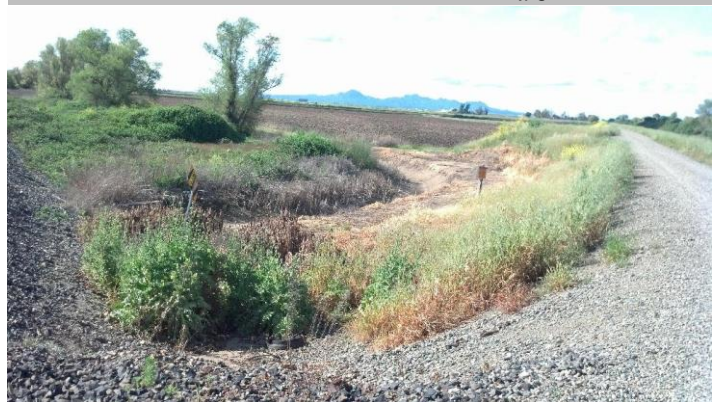
Photo 3 of 3 : UCIP_FA_2015_3740.jpg

Marker located on LS.

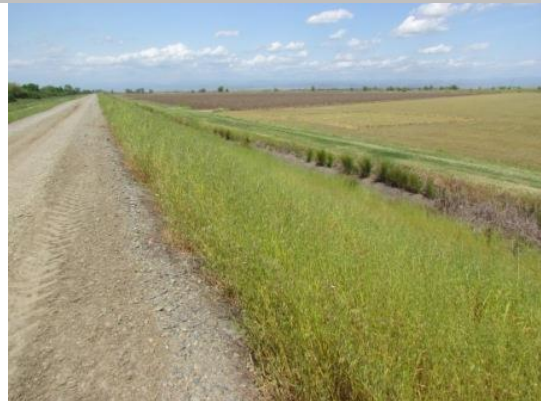
Photo 1 of 1 : FA_2015_MA0013_301_13_20150910_00006.jpg

LM Start	10.03	Rating **	M	Issue No.	13
LM End	10.52	Issue Type +	En	Location *	LS
Category	Earthen Levee			GPS Latitude/Longitude	
				Start	End
Item	Encroachments			39.471517 °	39.465113 °
				-121.739433 °	-121.743592 °
DWR ID	DWR_MA0013_02_s_2012_13				
Action/Comments					
Ditch

View of the agricultural ditch along the toe.

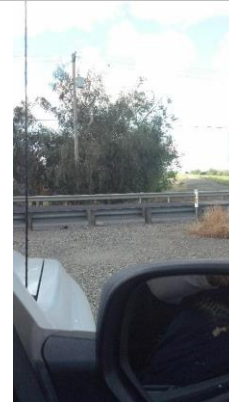
Photo 1 of 3 : UCIP_FA_2015_5315.jpg

Action/Comments					
Inspector Comments: FS_ID:46240 DS_ID:16406 EP_NO: 1238 FS_HLM: 10.67 Repair Type: Non-Urgent Crossing Status: Indicator Found UCIP Comments: 6/30/2015 Crossing appears in good condition.					
Permit was approved for 6-5/8 inch diameter not 8 inch. The permit granted permission to construct pipe to cross Cherokee Canal, Butte Creek, Clear Creek, & Ash Creek. The O&M manual list an 8 inch steel gas line at HLM 10.67, unable to determine if the gas line is the same crossing. Will need to contact applicant to obtain records.7/8/2013 Same as last inspection.12/4/2013 Same as last inspection.5/28/2014 Same as last inspection.					
FIELD_STRUCT_DESC: 8-inch gas pipe through the levee at unknown elevation. (Permit No. 1238-1947) Utility marker visible at the upstream face of highway bridge. Buried utility crosses bridge and crosses left bank of Cherokee Canal downstream of highway bridge. This entry matches the Drainage or Irrigation Structure referenced in O&M manual (HLM 10.67).

Downstream utility marker is located across highway.

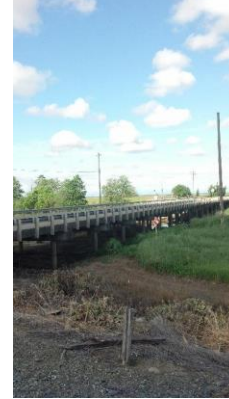
Photo 2 of 3 : UCIP_FA_2015_5316.jpg

Utility marker is located near the upstream face of the highway bridge.

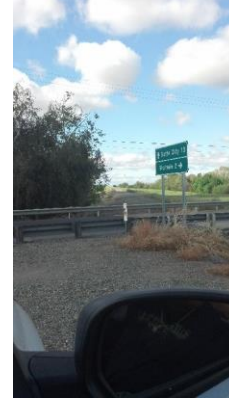
Photo 3 of 3 : UCIP_FA_2015_5317.jpg

Item	DWR UCIP Field Study			39.464710 °	39.464710 °	
				-121.743810 °	-121.743810 °	
DWR ID						
Action/Comments						
Inspector Comments: FS_ID:46240 DS_ID:16406 EP_NO: 1238 FS_HLM: 10.67 Repair Type: Non-Urgent Crossing Status: Indicator Found UCIP Comments: 6/30/2015 Crossing appears in good condition. Permit was approved for 6-5/8 inch diameter not 8 inch. The permit granted permission to construct pipe to cross Cherokee Canal, Butte Creek, Clear Creek, & Ash Creek. The O&M manual list an 8 inch steel gas line at HLM 10.67, unable to determine if the gas line is the same crossing. Will need to contact applicant to obtain records.7/8/2013 Same as last inspection.12/4/2013 Same as last inspection. inspection.5/28/2014 Same as last inspection. FIELD_STRUCT_DESC: 8-inch gas pipe through the levee at unknown elevation. (Permit No. 1238-1947) Utility marker visible at the upstream face of highway bridge. Buried utility crosses bridge and crosses left bank of Cherokee Canal downstream of highway bridge. This entry matches the Drainage or Irrigation Structure referenced in O&M manual (HLM 10.67). FS Date: 07/16/2015

Utility is angled. Alignment crosses highway.

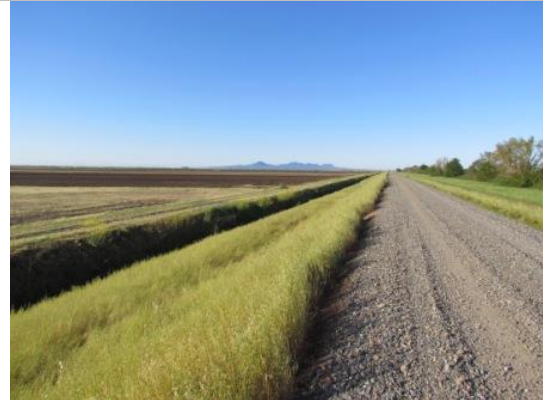
Photo 1 of 1 : FA_2015_MA0013_301_18_20150910_00007.jpg

LM Start	10.59	Rating **	M	Issue No.	18
LM End	11.66	Issue Type +	En	Location *	LS
Category	Earthen Levee			GPS Latitude/Longitude	
				Start	End
Item	Encroachments			39.464305 °	39.450333 °
				-121.744172 °	-121.753157 °
DWR ID	DWR_MA0013_02_s_2012_18				
Action/Comments					
Ditch

View of the agricultural ditch along the toe.

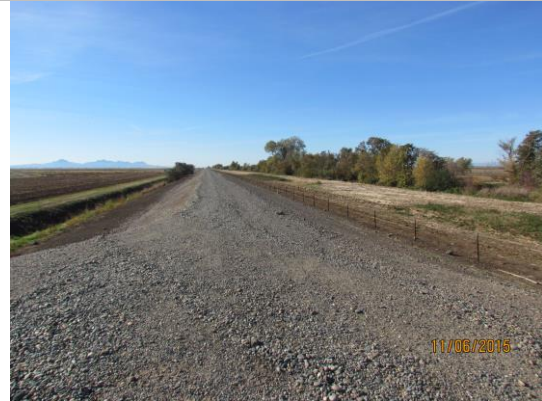
Photo 1 of 1 : FA_2015_MA0013_301_53_20151109_00023.jpg

LM Start	10.61	Rating **	A	Issue No.	53
LM End	10.61	Issue Type +	Ma	Location *	LS
Category	Earthen Levee			GPS Latitude/Longitude	
				Start	End
Item	Vegetation			39.463958 °	39.463958
				-121.744365 °	-121.744365
DWR ID	DWR_MA0013_02_f_2015_53				
Action/Comments					
Control annual grass and weeds on the levee slopes and easements. Inspector Comments: Sutter Yard burned and dragged both slopes.

View of no vegetation on both slopes.

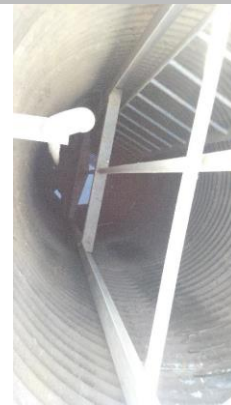
Photo 1 of 3 : UCIP_FA_2015_5318.jpg

LM Start	12.88	Rating **	M	Issue No.	937
LM End	12.88	Issue Type +	En	Location *	LS
Category	Supplemental			GPS Latitude/Longitude	
				Start	End
Item	DWR UCIP Field Study			39.434779 °	39.434779 °
				-121.763940 °	-121.763940 °
DWR ID					
Action/Comments					
Inspector Comments: FS_ID:46242 DS_ID:16385 EP_NO: N/A FS_HLM: 13.03 Repair Type: Non-Urgent Crossing Status: Found UCIP Comments: 6/30/2015 WS heavily vegetated passed the toe-road and could not make it to the WS pipe end for inspection. Vegetation needs to be cleared back. LS pipe end was fully submerged under water.LS pipe & slide gate sedimented in. Limited inspection WS and LS slopes due to dense vegetation. Need photos of cleared WS and LS slopes during next inspection. This crossing was listed in the USACE Periodic Inspection report as Corp's inspect ID# USACE_CESPK_M13F_2011_p_0147 for limited visibility of LS and WS.7/8/2013 LS slope has been cleared of vegetation and is in good condition. LS headwall is now visible but mostly underwater so unable to do full inspection. WS is still vegetated.12/4/2013 Same as last inspection.5/28/2014 Same as last inspection. FIELD_STRUCT_DESC: 30-inch corrugated metal pipe through the levee, 13.0 feet below the crown. Slide gate in corrugated metal pipe riser on the waterward slope. Slide gate in ditch on the landward side. Pipe under channel is a 24-inch Delleher siphon (USACE-1960). This entry matches the Drainage or Irrigation Structure referenced in O&M manual (HLM 13.03). FS Date: 07/16/2015

View of the inside of the WS stand pipe. No obstructions blocking slide gate.

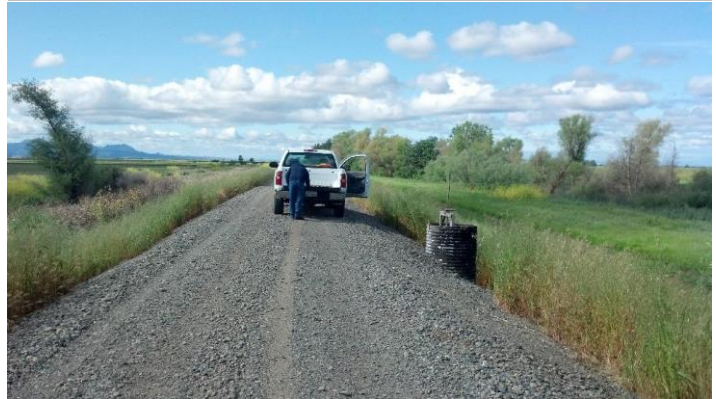
Photo 2 of 3 : UCIP_FA_2015_5319.jpg

LM Start	12.88	Rating **	M	Issue No.	937 (cont)
LM End	12.88	Issue Type +	En	Location *	LS
Category	Supplemental			GPS Latitude/Longitude	
				Start	End
Item	DWR UCIP Field Study			39.434779 °	39.434779 °
				-121.763940 °	-121.763940 °
DWR ID					
Action/Comments					
Inspector Comments: FS_ID:46242					
DS_ID:16385					
EP_NO: N/A					
FS_HLM: 13.03					
Repair Type: Non-Urgent					
Crossing Status: Found					
UCIP Comments: 6/30/2015 WS heavily vegetated passed the toe-road and could not make it to the WS pipe end for inspection.					
Vegetation needs to be cleared back. LS pipe end was fully submerged under water.LS pipe & slide gate sedimented in. Limited inspection WS and LS slopes due to dense vegetation. Need photos of cleared WS and LS slopes during next inspection. This crossing was listed in the USACE Periodic Inspection report as Corp's inspect ID# USACE_CESPK_M13F_2011_p_0147 for limited visibility of LS and WS.7/8/2013 LS slope has been cleared of vegetation and is in good condition. LS headwall is now visible but mostly underwater so unable to do full inspection. WS is still vegetated.12/4/2013 Same as last inspection.5/28/2014 Same as last inspection.

FIELD_STRUCT_DESC: 30-inch corrugated metal pipe through the levee, 13.0 feet below the crown. Slide gate in corrugated metal pipe riser on the waterward slope. Slide gate in ditch on the landward side. Pipe under channel is a 24-inch Delleher siphon (USACE-1960). This entry matches the Drainage or Irrigation Structure referenced in O&M manual (HLM 13.03).					
FS Date: 07/16/2015

Overview of crossing looking downstream at the left bank of Cherokee Canal.

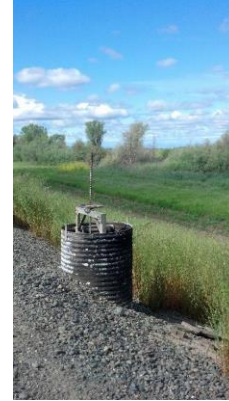
Photo 3 of 3 : UCIP_FA_2015_5320.jpg

Item	DWR UCIP Field Study			39.434779 °	39.434779 °	
				-121.763940 °	-121.763940 °	
DWR ID						
Action/Comments						
Inspector Comments: FS_ID:46242						
DS_ID:16385						
EP_NO: N/A						
FS_HLM: 13.03						
Repair Type: Non-Urgent						
Crossing Status: Found						
UCIP Comments: 6/30/2015 WS heavily vegetated passed the toe-road and could not make it to the WS pipe end for inspection. Vegetation needs to be cleared back. LS pipe end was fully submerged under water.LS pipe & slide gate sedimented in. Limited inspection WS and LS slopes due to dense vegetation. Need photos of cleared WS and LS slopes during next inspection. This crossing was listed in the USACE Periodic Inspection report as Corp's inspect ID# USACE_CESPK_M13F_2011_p_0147 for limited visibility of LS and WS.7/8/2013 LS slope has been cleared of vegetation and is in good condition. LS headwall is now visible but mostly underwater so unable to do full inspection. WS is still vegetated.12/4/2013 Same as last inspection.5/28/2014 Same as last inspection.

Stand pipe with screw gate WS

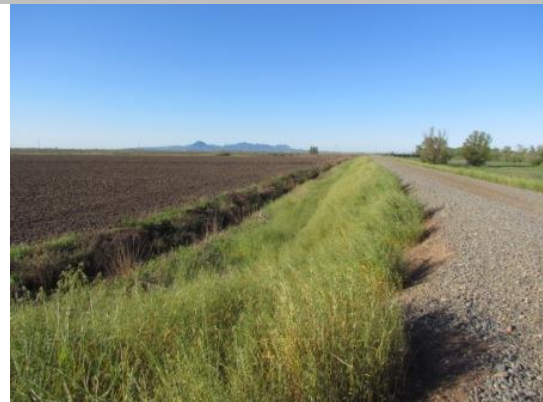
Photo 1 of 1 : FA_2015_MA0013_301_19_20150910_00008.jpg

LM Start	13.40	Rating **	M	Issue No.	19
LM End	16.88	Issue Type +	En	Location *	LS
Category	Earthen Levee			GPS Latitude/Longitude	
				Start	End
Item	Encroachments			39.428192 °	39.406240 °
				-121.768443 °	-121.794863 °
DWR ID	DWR_MA0013_02_s_2012_19				
Action/Comments					
Ditch

View of the agricultural ditch along the toe.

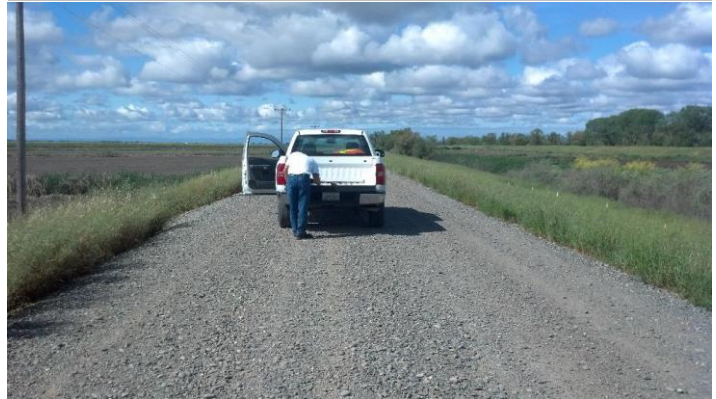
Photo 1 of 3 : UCIP_FA_2015_5321.jpg

Action/Comments					
Inspector Comments: FS_ID:46243 DS_ID:16376 EP_NO: N/A FS_HLM: 15.618 Repair Type: Non-Urgent Crossing Status: Found UCIP Comments: 6/30/2015 Still unable to locate the LS pipe end. Could not find LS end of pipe. Limited inspection on WS and LS slopes and toe due to dense vegetation. Need photos of cleared WS and LS slopes, and LS headwall during next inspection. This crossing was listed in the USACE Periodic Inspection report as Corp's inspect ID# USACE_CESPK_M13E_2011_p_0011 for WS gate blocked by vegetation. 7/8/2013 WS slope has been cleared of vegetation and is in good condition. LS slope also cleared of vegetation but still very dense on LS toe and unable to locate LS headwall. 12/4/2013 Same as last inspection. WS flapgate was bolted shut to keep LS ricefield flooded. 5/28/2014 Same as last inspection. FIELD_STRUCT_DESC: 24-inch corrugated metal pipe through the levee, 10.1 feet below the crown. Flap gate on the waterward end. Concrete "U" headwalls on both ends (USACE-1960). This entry matches the Drainage or Irrigation Structure referenced in O&M manual (HLM 15.62). FS Date: 07/16/2015

Overview of crossing looking downstream at the left bank of Cherokee Canal.

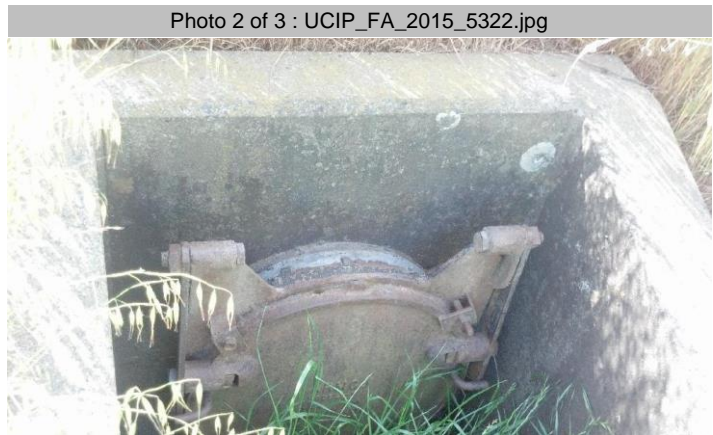
Action/Comments					
Inspector Comments: FS_ID:46243 DS_ID:16376 EP_NO: N/A FS_HLM: 15.618 Repair Type: Non-Urgent Crossing Status: Found UCIP Comments: 6/30/2015 Still unable to locate the LS pipe end. Could not find LS end of pipe. Limited inspection on WS and LS slopes and toe due to dense vegetation. Need photos of cleared WS and LS slopes, and LS headwall during next inspection. This crossing was listed in the USACE Periodic Inspection report as Corp's inspect ID# USACE_CESPK_M13E_2011_p_0011 for WS gate blocked by vegetation. 7/8/2013 WS slope has been cleared of vegetation and is in good condition. LS slope also cleared of vegetation but still very dense on LS toe and unable to locate LS headwall. 12/4/2013 Same as last inspection. WS flapgate was bolted shut to keep LS ricefield flooded. 5/28/2014 Same as last inspection. FIELD_STRUCT_DESC: 24-inch corrugated metal pipe through the levee, 10.1 feet below the crown. Flap gate on the waterward end. Concrete "U" headwalls on both ends (USACE-1960). This entry matches the Drainage or Irrigation Structure referenced in O&M manual (HLM 15.62). FS Date: 07/16/2015

View of WS headwall and flap gate.

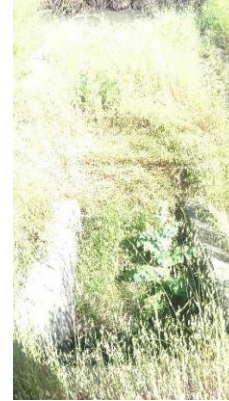
Photo 1 of 3 : UCIP_FA_2015_5324.jpg

View of WS headwall.

Action/Comments					
Inspector Comments: FS_ID:46245 DS_ID:16382 EP_NO: N/A FS_HLM: 15.864 Repair Type: Non-Urgent Crossing Status: Found UCIP Comments: 6/30/2015 LS headwall stil buried somewhere. WS looked to be in good condition.LS headwall buried. Limited inspection on WS and LS slopes due to dense vegetation. Need photos of cleared WS and LS slopes during next inspection. Need to determine the fate of LS headwall. This crossing was listed in the USACE Periodic Inspection report as Corp's inspect ID# USACE_CESPK_M13E_2011_p_0022 -- unknown issue.7/8/2013 Same as last inspection.12/4/2013 Same as last inspection.5/28/2014 Same as last inspection. FIELD_STRUCT_DESC: 24-inch corrugated metal pipe through the levee, 9.0 feet below the crown. Flap gate on waterward end. Concrete "U" headwalls on both ends (USACE-1960). This entry matches the Drainage or Irrigation Structure referenced in O&M manual (HLM 15.87). FS Date: 07/16/2015

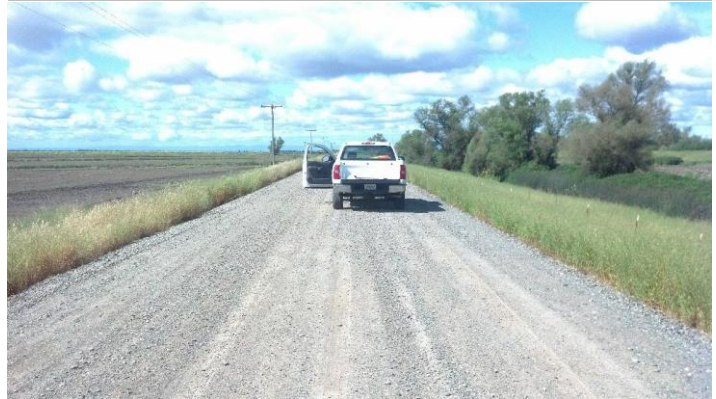
Photo 3 of 3 : UCIP_FA_2015_5409.jpg

Item	DWR UCIP Field Study			39.417043 °	39.417043 °	
				-121.777240 °	-121.777240 °	
DWR ID						
Action/Comments						
Inspector Comments: FS_ID:46245 DS_ID:16382 EP_NO: N/A FS_HLM: 15.864 Repair Type: Non-Urgent Crossing Status: Found UCIP Comments: 6/30/2015 LS headwall stil buried somewhere. WS looked to be in good condition.LS headwall buried. Limited inspection on WS and LS slopes due to dense vegetation. Need photos of cleared WS and LS slopes during next inspection. Need to determine the fate of LS headwall. This crossing was listed in the USACE Periodic Inspection report as Corp's inspect ID# USACE_CESPK_M13E_2011_p_0022 -- unknown issue.7/8/2013 Same as last inspection.12/4/2013 Same as last inspection.5/28/2014 Same as last inspection. FIELD_STRUCT_DESC: 24-inch corrugated metal pipe through the levee, 9.0 feet below the crown. Flap gate on waterward end. Concrete "U" headwalls on both ends (USACE-1960). This entry matches the Drainage or Irrigation Structure referenced in O&M manual (HLM 15.87). FS Date: 07/16/2015

Overview of crossing looking downstream of the left bank of Cherokee

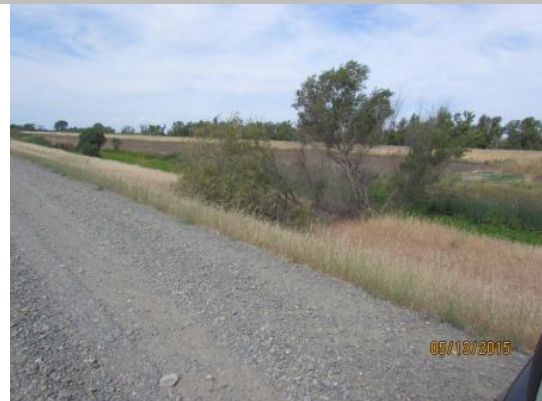
Photo 1 of 1 : FA_2015_MA0013_301_61_20150910_00018.jpg

LM Start	15.97	Rating **	M	Issue No.	61
LM End	15.97	Issue Type +	Ma	Location *	WS
Category	Earthen Levee			GPS Latitude/Longitude	
				Start	End
Item	Encroachments			39.414448 °	39.414448 °
				-121.781532 °	-121.781532 °
DWR ID	DWR_MA0013_02_s_2015_61				
Action/Comments					
Tree or limb					
Inspector Comments: Remove the tree from the waterside slope and toe.

View of the tree along the waterside toe and slope.

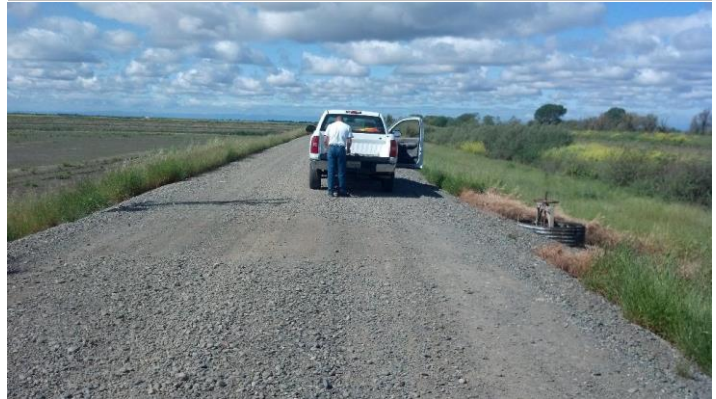
Photo 1 of 3 : UCIP_FA_2015_5410.jpg

UCIP Comments: 6/30/2015 Bee boxes stacked near the riser box on WS so could not get close enough to see if the leak issue had been fixed. Limited inspection on LS slope due to dense vegetation. Need photos of cleared LS slope and LS headwall. Cracks in riser box. New pump installed recently this work might be covered under separate permit. 7/8/2013 LS slope has been cleared of vegetation and is in good condition. LS headwall was underwater and unable to be inspected. All WS appurtenances in good condition. 12/4/2013 Same as last inspection. 5/28/2014 Water appears to be leaking out of the WS concrete riser box. Causing minor erosion under pipe near pump structure.

Overview of levee crown.

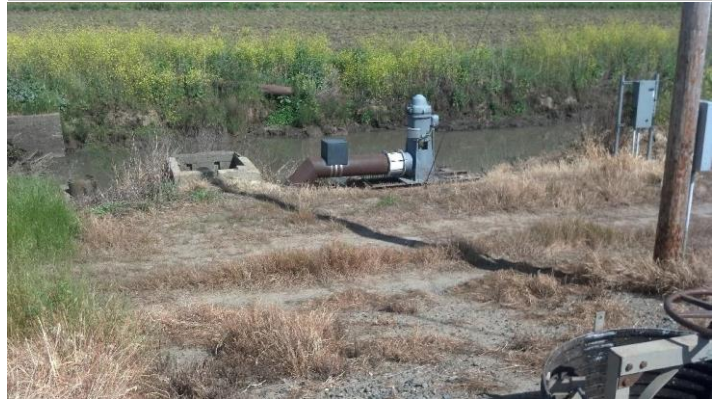
Photo 2 of 3 : UCIP_FA_2015_5411.jpg

UCIP Comments: 6/30/2015 Bee boxes stacked near the riser box on WS so could not get close enough to see if the leak issue had been fixed. Limited inspection on LS slope due to dense vegetation. Need photos of cleared LS slope and LS headwall. Cracks in riser box. New pump installed recently this work might be covered under separate permit. 7/8/2013 LS slope has been cleared of vegetation and is in good condition. LS headwall was underwater and unable to be inspected. All WS appurtenances in good condition. 12/4/2013 Same as last inspection. 5/28/2014 Water appears to be leaking out of the WS concrete riser box. Causing minor erosion under pipe near pump structure.

WS view of crossing.

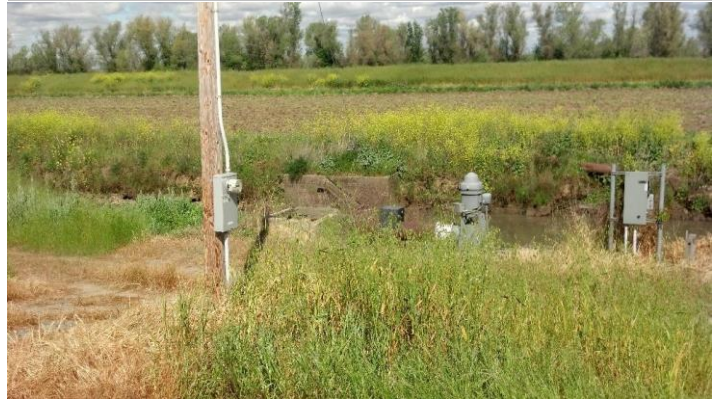
Photo 3 of 3 : UCIP_FA_2015_5412.jpg

UCIP Comments: 6/30/2015 Bee boxes stacked near the riser box on WS so could not get close enough to see if the leak issue had been fixed. Limited inspection on LS slope due to dense vegetation. Need photos of cleared LS slope and LS headwall. Cracks in riser box. New pump installed recently this work might be covered under separate permit. 7/8/2013 LS slope has been cleared of vegetation and is in good condition. LS headwall was underwater and unable to be inspected. All WS appurtenances in good condition. 12/4/2013 Same as last inspection. 5/28/2014 Water appears to be leaking out of the WS concrete riser box. Causing minor erosion under pipe near pump structure.

Appurtenances on WS.

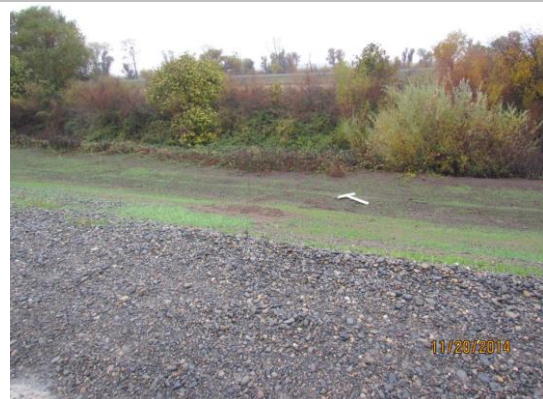
Photo 1 of 1 : FA_2015_MA0013_301_54_20150910_00013.jpg

LM Start	16.52	Rating **	M	Issue No.	54
LM End	16.52	Issue Type +	Ma	Location *	WS
Category	Earthen Levee			GPS Latitude/Longitude	
				Start	End
Item	Animal Control			39.409548 °	39.409548 °
				-121.789668 °	-121.789668 °
DWR ID	DWR_MA0013_02_f_2014_54

View of the rodent holes and bait station along the waterside slope.

No rodents visible, but rodent burrows visible; need to backfill and compact or grout burrows.
Inspector Comments: Repair the rodent holes along the water side slope.

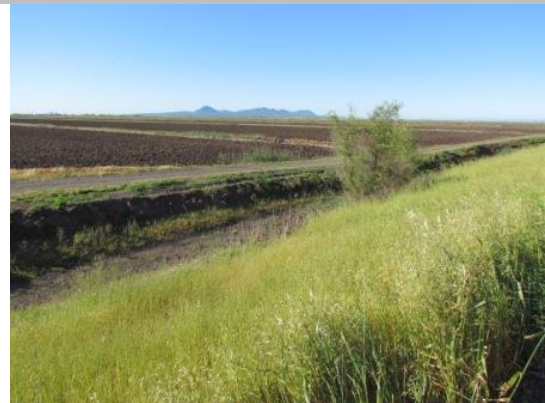
Photo 1 of 1 : FA_2015_MA0013_301_20_20150910_00009.jpg

Action/Comments					
Ditch

View of the agricultural ditch along the toe.

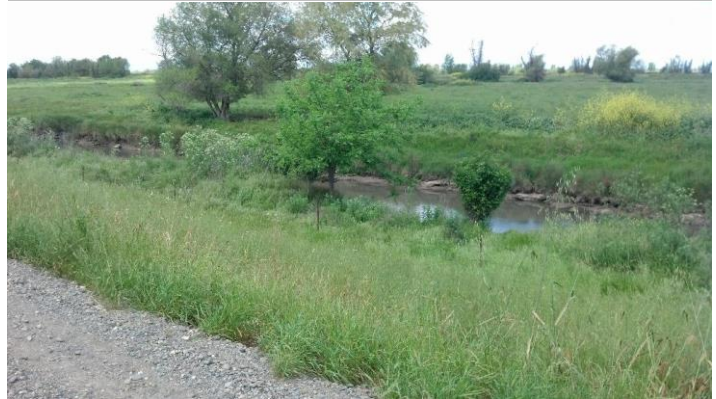
Photo 1 of 3 : UCIP_FA_2015_5413.jpg

Action/Comments					
Inspector Comments: FS_ID:46249 DS_ID:16379 EP_NO: N/A FS_HLM: 18.369 Repair Type: Non-Urgent Crossing Status: Found UCIP Comments: 6/30/2015 Vegetation still present on WS. LS side was underwater during inspection. Limited inspection on WS and LS slopes due to dense vegetation. Need photos of cleared WS and LS slopes. This crossing was listed in the USACE Periodic Inspection report as Corp's inspect ID# USACE_CESPK_M13E_2011_p_0134 for unknown culvert size on LS and no outlet visible on WS. 7/8/2013 LS slope cleared of vegetation and is in good condition. WS is still vegetated. LS pipe end under water and blocked off by plywood so unable to measure culvert size. 12/4/2013 Same as last inspection. 5/28/2014 Same as last inspection. FIELD_STRUCT_DESC: 36-inch corrugated metal pipe through the levee, 13.2 feet below the crown. Flap gate on the waterward end. Concrete "U" headwalls on both ends (USACE-1960). This entry matches the Drainage or Irrigation Structure referenced in O&M manual (HLM 18.37). FS Date: 07/16/2015

View of WS slope and berm.

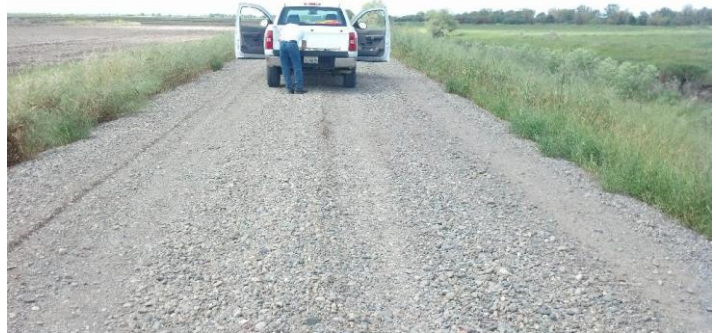
Photo 2 of 3 : UCIP_FA_2015_5414.jpg

Inspector Comments: FS_ID:46249
 DS_ID:16379
 EP_NO: N/A
 FS_HLM: 18.369
 Repair Type: Non-Urgent
 Crossing Status: Found
 UCIP Comments: 6/30/2015 Vegetation still present on WS. LS side was underwater during inspection. Limited inspection on WS and LS slopes due to dense vegetation. Need photos of cleared WS and LS slopes. This crossing was listed in the USACE Periodic Inspection report as Corp's inspect ID# USACE_CESPK_M13E_2011_p_0134 for unknown culvert size on LS and no outlet visible on WS. 7/8/2013 LS slope cleared of vegetation and is in good condition. WS is still vegetated. LS pipe end under water and blocked off by plywood so unable to measure culvert size. 12/4/2013 Same as last inspection. 5/28/2014 Same as last inspection.
 FIELD_STRUCT_DESC: 36-inch corrugated metal pipe through the levee, 13.2 feet below the crown. Flap gate on the waterward end. Concrete "U" headwalls on both ends (USACE-1960). This entry matches the Drainage or Irrigation Structure referenced in O&M manual (HLM 18.37).

Overview of crossing looking D/S at left bank of Cherokee Canal.

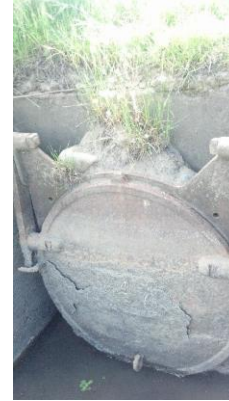
Photo 3 of 3 : UCIP_FA_2015_5415.jpg

Item	DWR UCIP Field Study			39.394406 °	39.394406 °	
				-121.813180 °	-121.813180 °	
DWR ID						
Action/Comments						
Inspector Comments: FS_ID:46249						
DS_ID:16379						
EP_NO: N/A						
FS_HLM: 18.369						
Repair Type: Non-Urgent						
Crossing Status: Found						
UCIP Comments: 6/30/2015 Vegetation still present on WS. LS side was underwater during inspection. Limited inspection on WS and LS slopes due to dense vegetation. Need photos of cleared WS and LS slopes. This crossing was listed in the USACE Periodic Inspection report as Corp's inspect ID# USACE_CESPK_M13E_2011_p_0134 for unknown culvert size on LS and no outlet visible on WS. 7/8/2013 LS slope cleared of vegetation and is in good condition. WS is still vegetated. LS pipe end under water and blocked off by plywood so unable to measure culvert size. 12/4/2013 Same as last inspection. 5/28/2014 Same as last inspection.						
FIELD_STRUCT_DESC: 36-inch corrugated metal pipe through the levee, 13.2 feet below the crown. Flap gate on the waterward end. Concrete "U" headwalls on both ends (USACE-1960). This entry matches the Drainage or Irrigation Structure referenced in O&M manual (HLM 18.37).

View of flap gate located on WS.

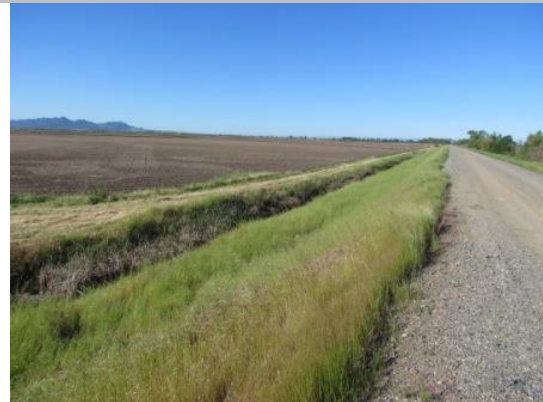
Photo 1 of 1 : FA_2015_MA0013_301_21_20150910_00010.jpg

LM Start	19.37	Rating **	M	Issue No.	21
LM End	19.92	Issue Type +	En	Location *	LS
Category	Earthen Levee			GPS Latitude/Longitude	
				Start	End
Item	Encroachments			39.383252 °	39.378192 °
				-121.830565 °	-121.838543 °
DWR ID	DWR_MA0013_02_s_2012_21				
Action/Comments					
Ditch

View of the agricultural ditch along the toe.

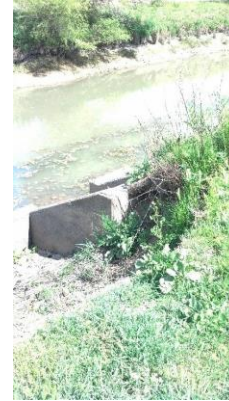
Photo 2 of 3 : UCIP_FA_2015_3761.jpg

Action/Comments					
Inspector Comments: FS_ID:46252 DS_ID:16375 EP_NO: N/A FS_HLM: 20.148 Repair Type: Non-Urgent Crossing Status: Found UCIP Comments: 6/30/2015 Erosion still present behind the WS headwall. Everything else with the crossing appeared to be in good condition. Erosion present behind WS headwall. Limited inspection on WS and LS slopes due to dense vegetation. Need photos of cleared WS and LS slopes during next inspection. 7/8/2013 Erosion problem same as last inspection. WS and LS slopes have been cleared of vegetation and are in good shape. 12/4/2013 Same as last inspection. 5/28/2014 Same as last inspection. FIELD_STRUCT_DESC: 30-inch corrugated metal pipe through the levee, 13.1 feet below the crown. Flap gate on the waterward end. Concrete "U" headwalls on both ends (USACE-1960). This entry matches the Drainage or Irrigation Structure referenced in O&M manual (HLM 20.15). FS Date: 07/16/2015

Erosion behind WS headwall looking at the downstream edge of headwall.

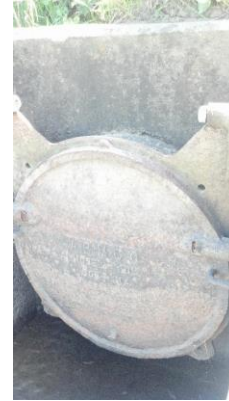
Photo 3 of 3 : UCIP_FA_2015_3762.jpg

LM Start	19.92	Rating **	M	Issue No.	943 (cont)
LM End	19.92	Issue Type +	En	Location *	LS
Category	Supplemental			GPS Latitude/Longitude	
				Start	End
Item	DWR UCIP Field Study			39.378198 °	39.378198 °
				-121.838570 °	-121.838570 °
DWR ID					
Action/Comments					
Inspector Comments: FS_ID:46252 DS_ID:16375 EP_NO: N/A FS_HLM: 20.148 Repair Type: Non-Urgent Crossing Status: Found UCIP Comments: 6/30/2015 Erosioon still present behind the WS headwall. Everyhting thing else with the crossing appeared to be in good condition.Erosion present behind WS headwall. Limited inspection on WS and LS slopes due to dense vegetation. Need photos of cleared WS and LS slopes during next inspection.7/8/2013 Erosion problem same as last inspection. WS and LS slopes have been cleared of vegetation and are in good shape.12/4/2013 Same as last inspection.5/28/2014 Same as last inspection. FIELD_STRUCT_DESC: 30-inch corrugated metal pipe through the levee, 13.1 feet below the crown. Flap gate on the waterward end. Concrete "U" headwalls on both ends (USACE-1960). This entry matches the Drainage or Irrigation Structure referenced in O&M manual (HLM 20.15). FS Date: 07/16/2015

Flap gate located on the WS.

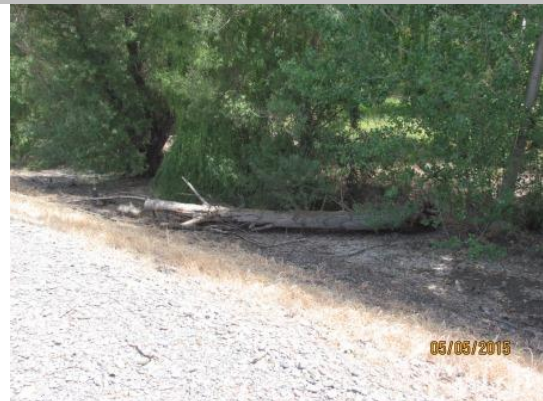
Photo 1 of 1 : FA_2015_MA0013_301_51_20150910_00011.jpg

LM Start	20.45	Rating **	M	Issue No.	51
LM End	20.45	Issue Type +	Ma	Location *	LS
Category	Earthen Levee			GPS Latitude/Longitude	
				Start	End
Item	Encroachments			39.372912 °	39.372912 °
				-121.845500 °	-121.845500 °
DWR ID	DWR_MA0013_02_s_2015_51				
Action/Comments					
Tree or limb					
Inspector Comments: Remove the tree limbs from the landside toe.

View of the tree limbs along the landside toe.
